NASA Technical Memorandum 85679

VERTICAL DROP TEST OF A TRANSPORT FUSELAGE
SECTION LOCATED FORWARD OF THE WING

M. Susan Williams
Robert J. Hayduk

August 1983

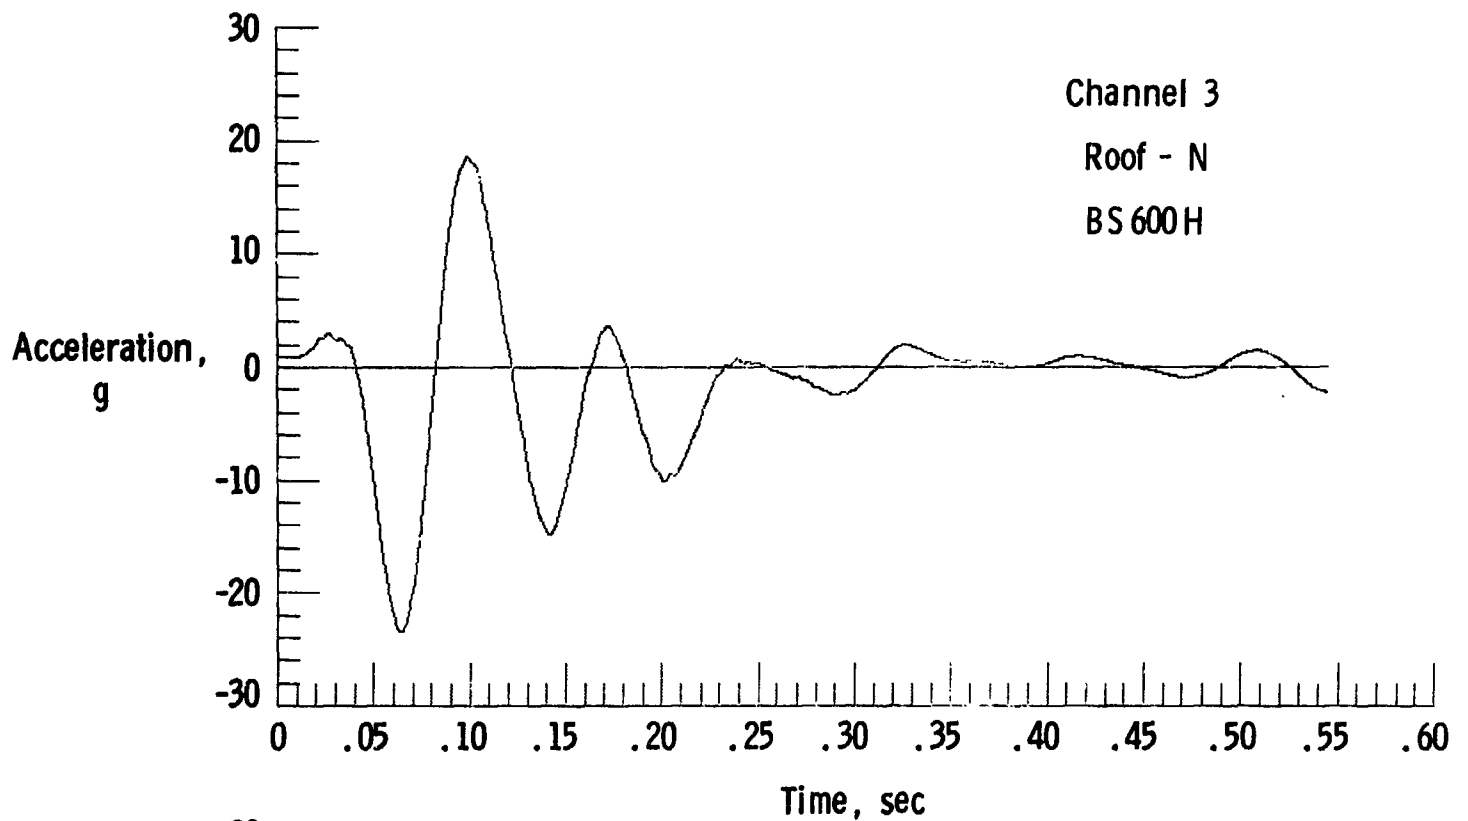
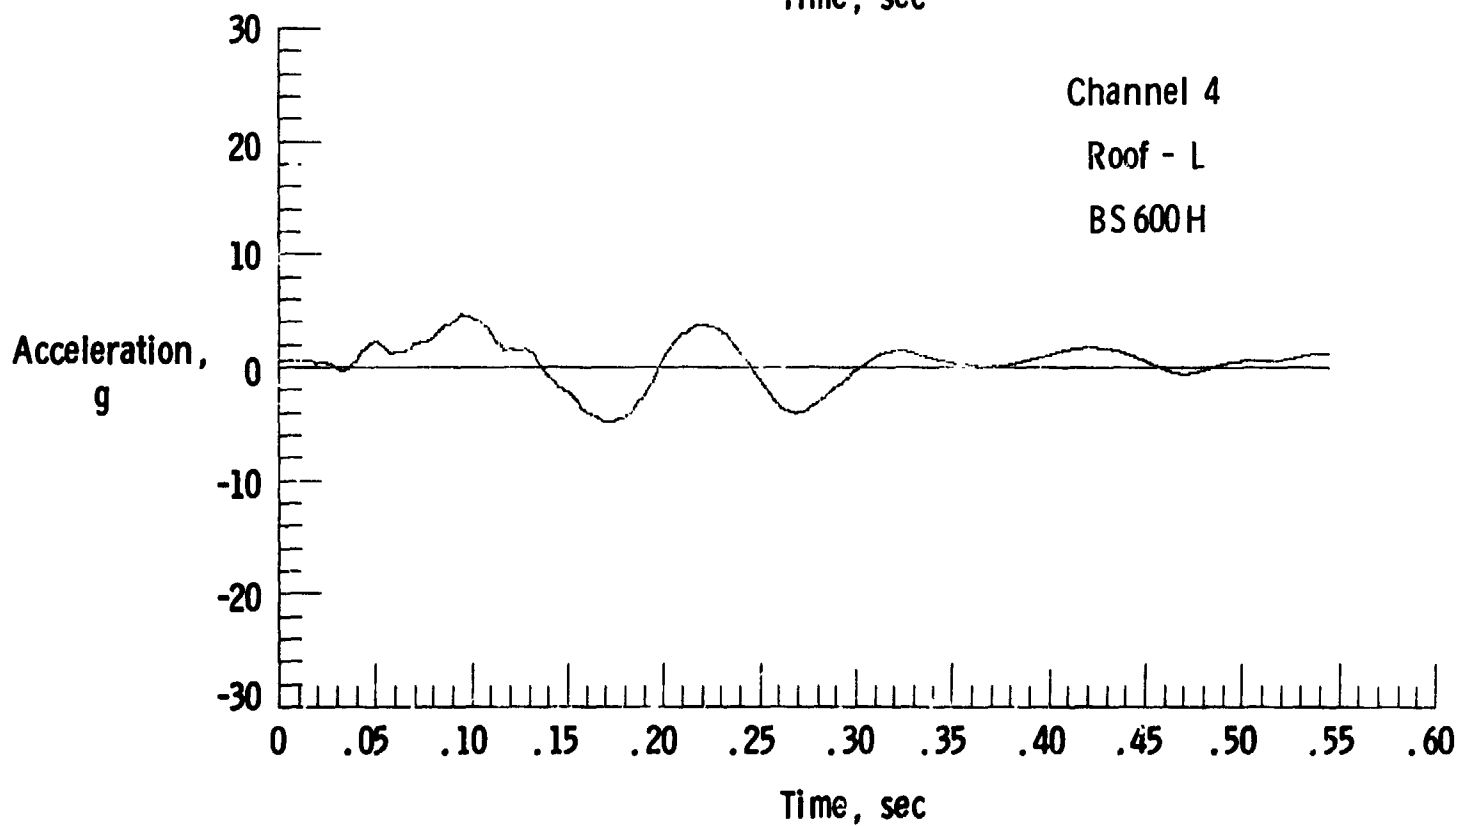
The highest normal acceleration level measured occurred, surprisingly, at the roof. The roof normal accelerometers at BS 600D and 600H (figures 9r and 9s) show an oscillatory rather than pulse response, as exhibited on the floor and undercarriage. Nearly 24 g for 0.04 sec was measured during the first half wave at BS 600H. This oscillatory response at the roof is in the 10 to 12 cycle per second range, clearly at structural vibration levels.

(s) Structural acceleration time histories.
Figure 9.- Concluded.
